United States Environmental Protection Agency Environmental Monitoring Systems Laboratory P.O. Box 93478 Las Vegas, NV 89193-3478 TS-PIC-88704 March 1988

AERIAL PHOTOGRAPHIC ANALYSIS OF WASTE DISPOSAL, INCORPORATED Whittier, California

This report presents a historical analysis of the Waste Disposal, Incorporated facility located in Whittier, California. Archival aerial photography spanning 60 years (1928-1987) was used as the primary information source for the preparation of this report.

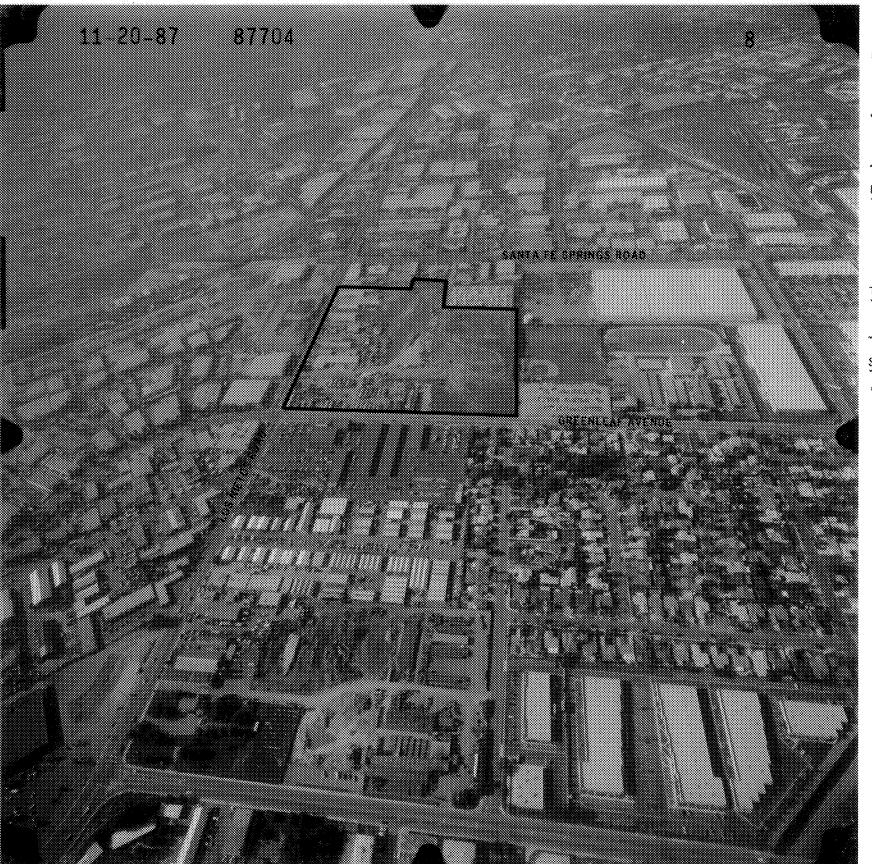
Figure 13. Waste Disposal, Incorporated, November 20, 1987. Oblique looking northwest.

WL WETLAND NOVEMBER 20, 1987 (FIGURE 13)

This photograph presents an oblique view of the Waste Disposal, Incorporated facility. The view is looking to the northwest.
